Coating Inspection and Structural Deficiencies

By: John M. Lieb, P.E.
Chief Engineer

In August of 2010, the roof of a large municipal water storage tank in suburban Chicago collapsed. The tank had performed without incident for more than 35 years. There were no early indications or warnings of roof problems prior to the roof failure. The tank coating had been inspected a number of times after the tank was initially constructed. This article discusses what happened, how the roof failure could have been prevented and lessons learned from this incident.

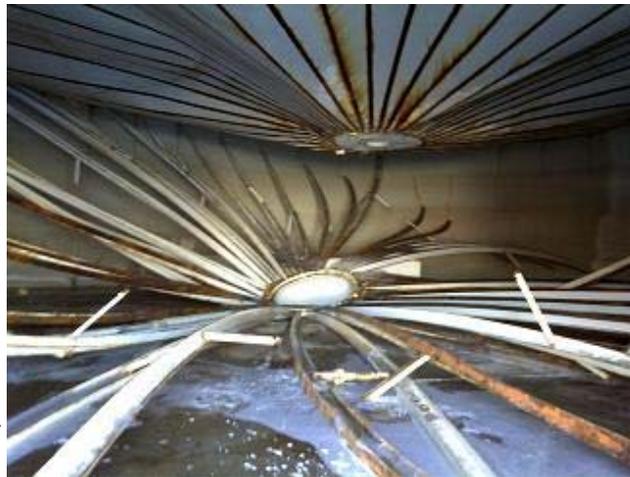
The first sign of a potential problem with the tank was unusual loud noises coming from the tank. External inspection revealed that the umbrella roof had inverted and there was evidence of torn rafter clip attachment welds around the top of the shell. No tank leaks were found. Following the collapse of the roof, an internal inspection revealed that the roof framing had collapsed or "spiraled down". Closer inspection revealed that only one bolt was in place at the end attachment to the rafter for the ma-

Collapsed Roof Structure on Tank Interior

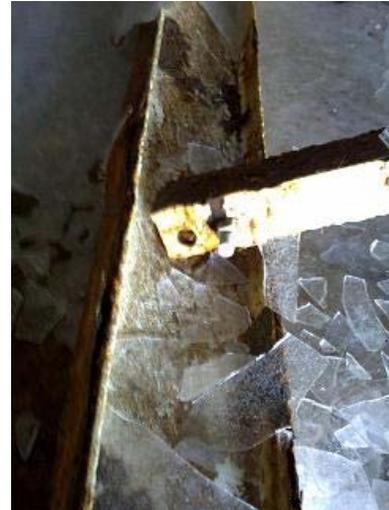
majority of the purlins. (See Photo No. 2) At the time of the inspection, there was no evidence that the second bolt at these connections had ever been in place. Several of the purlin ends where the second bolt was missing had deteriorated to the point that they were no longer capable of transferring load or performing their intended function to provide lateral stability to the roof structure. Without this lateral stability, the main rafters were vulnerable to "roll-over" or spiraling down under the self-weight of the roof and any external loads, such as wind. The collapse most likely resulted from progressive failure of the purlins as the load had to be carried by fewer and fewer of them. A contributing factor to the collapse was the accelerated corrosion in the empty bolt holes at the end of the purlins due to the coating failure within and on the edges of these holes.

Only one attachment bolt in place.

The failure of the tank roof could have been prevented by recognizing that the missing purlin bolts were a non-compliance with the tank construction drawings on record and represented a significant risk to the stability of the roof structure. A professional tank engineer, had one been involved in previous inspections, would almost certainly have recognized this non-compliance and failure risk before allowing the tank to be returned to service.

A critical step in the inspection of a tank, whether for municipal water or any material, is the review and evaluation of the inspection data by a qualified tank engineer. A professional tank engineer is trained and qualified to understand the engineering design and performance requirements for the tank and will recognize structural deficiencies that may be overlooked by the coating inspector.
